#### LAURIE JOHNSON CONSULTING

### M<sub>w</sub>8.8 Maule Earthquake February 27, 2010

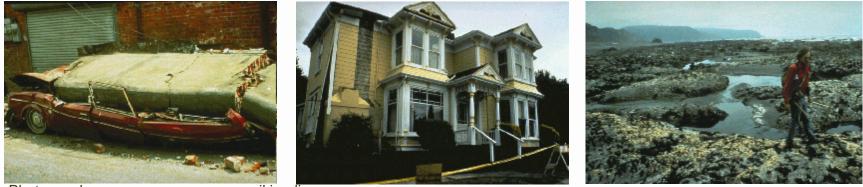
# M7.2 Cape Mendocino Earthquake and Tsunami (1992)

- n Main shock: M7.2, April 25, 1992, 11:06 am, near small town of Petrolia, Humboldt County, California
- n 2 Aftershocks: M6.5 and M6.7, morning of April 26
- n 25 km of uplift (1 meter max) along coast
- n Tsunami (1 foot max height) recorded along West Coast and Hawaii; reached near-field coast (1 min), Humboldt Bay (20 min), and Crescent City (50 min)

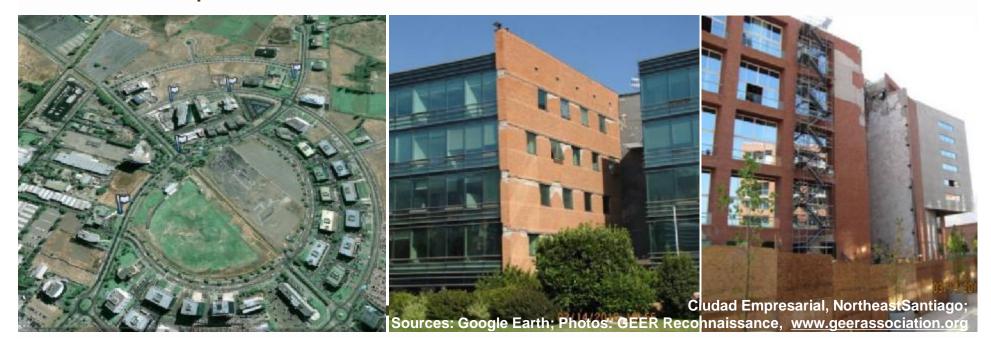
# Some structures on soft or poorly compacted soils had extensive damage

- n Included modern, engineered structures in Santiago, central valley, and along coast
- n Areas with higher water tables and near waterways– rivers, lakes, lagoons, bays, and beaches, most susceptible

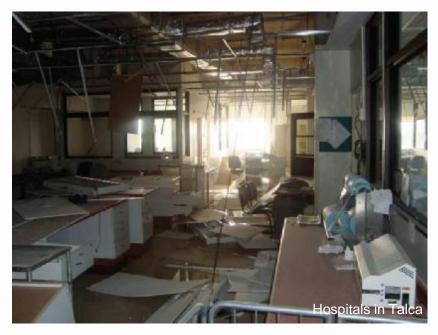
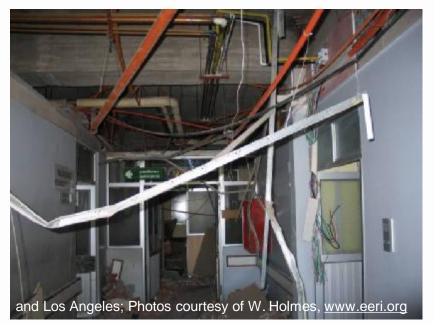
# Significant nonstructural losses even when buildings undamaged

- n Nonstructural systems very comparable to U.S. nonstructural walls, ceiling tiles, M/E/P equipment and distribution systems
- n Code-specified nonstructural protection not enforced

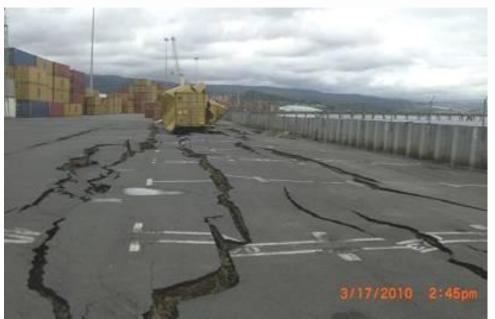
## Refineries: Aconcagua (west of Santiago) and Bio-Bio (near Concepcion)

- n Both refineries initially shut down (e.g. loss of power, check critical elements, appraise possible damage); only minor, non-critical structural damage
- n Aconcagua (98,000 bpd capacity) had only minor damage and restarted in 10 days
- n Bio-Bio (130,000 bpd capacity) sustained relatively minor damage but with more substantial effects
- n Damage from fallen heater refractory
- n Ground failures damaged floating roof tank and steel crude oil pipeline
- n Gasoline and diesel is being imported into the service area
- n 3 to 7 months estimated to restore operating capacity

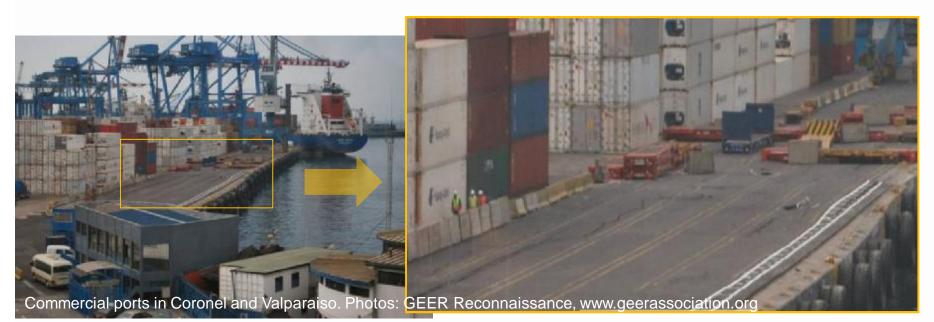
#### Ports

n Ground displacements to quay walls, sheet pile walls, wharf structures and pile foundations

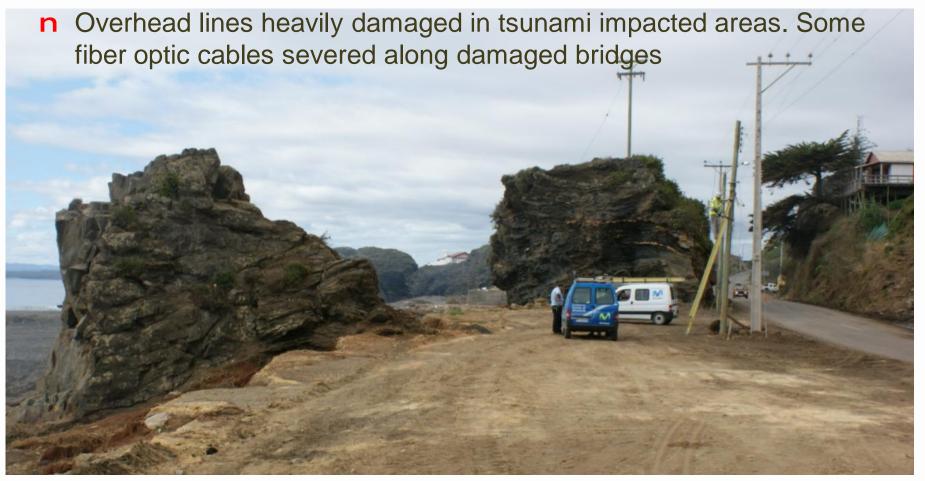
Source: Modified ASCE TCLEE Chile web report, May 2010; www.eeri.org; Photo: Telecom restoration in Pelluhue, Laurie Johnson

### Extensive setbacks to telecommunication performance and restoration

- n Overhead lines heavily damaged in tsunami impacted areas. Some fiber optic cables severed along damaged bridges
- n Only critical offices (e.g. central offices, switching offices, and fiber backbone carrier offices) had backup power generators
- n Majority of cell sites and remote offices had 3 to 4 hours and 8 hours of battery reserve power, respectively; ran out of power by late morning, Feb 27. Road and bridge damage limited access to these sites and ability to deploy portable generators
- n Other disruptions caused by unanchored battery racks and shelves, fallen antennas, and tower installation collapses
- n Both landline and wireless services restored in 7 days

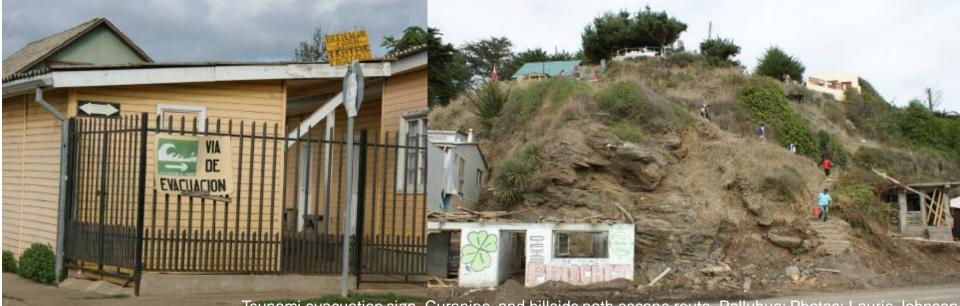
Tsunami evacuation sign, Curanipe, and hillside path escape route, Pelluhue; Photos: Laurie Johnson
